## K-300B Compressor Rotor Failure (2/13/2011)

Hydroprocessing, Rotating  
Equip Reliability (RER)

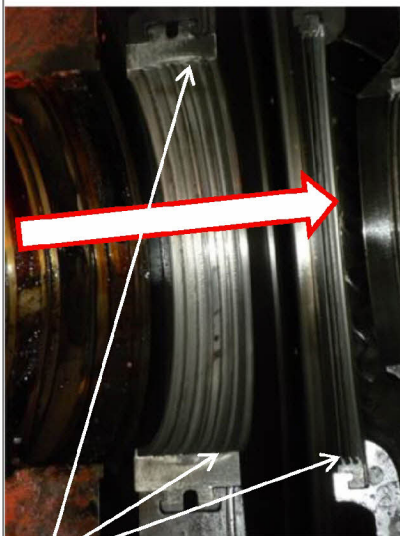
Damaged internal balance  
piston labyrinths

- 1) The K-300B thrust bearing and balance piston labyrinths, which maintain rotor axial position, had failed. This allowed the rotor to drift axially until the impellers damaged the diaphragms.
- 2) The rotor thrust load exceeded the capacity of the thrust bearing and could no longer be sustained due to decreased oil film thickness at the thrust pads.
- 3) The thrust pads and interlocking balance piston labyrinths were partially degraded from accumulated damage from prior startups involving progressive surge cycles. Each of these cycles resulted in axial rotor movement in excess of the thrust bearing clearances.
- 4) Lack of a good process control and monitoring system contributed to damage of the thrust bearing being undetected prior to this failure.

- 1) Implement a control system and operational improvements such as a dedicated surge avoidance procedure and system for both K-300 machines.
- 2) Install Bently vibration probes to monitor and protect the K-300's.
- 3) Rebalance the hydraulic axial load on the K-300A from thrust bearing to balance piston.
- 4) Determine whether installing instruments to continuously measure the pressure and flow from the balance piston cavity to the suction is feasible.
